# WATER QUALITY AND AQUATIC PLANT ASSESSMENT FREMONT LAKE FINAL REPORT

*DECEMBER 2016*

**ANGELA DE PALMA-DOW**, Department of Fisheries and Wildlife  
**LOIS WOLFSON**, Institute of Water Research, Department of Fisheries and Wildlife  
**ERICK ELGIN**, MSU Extension  
**ELIZABETH THROCKMORTON**, Department of Fisheries and Wildlife  
**MICHIGAN STATE UNIVERSITY, EAST LANSING, MICHIGAN, USA**

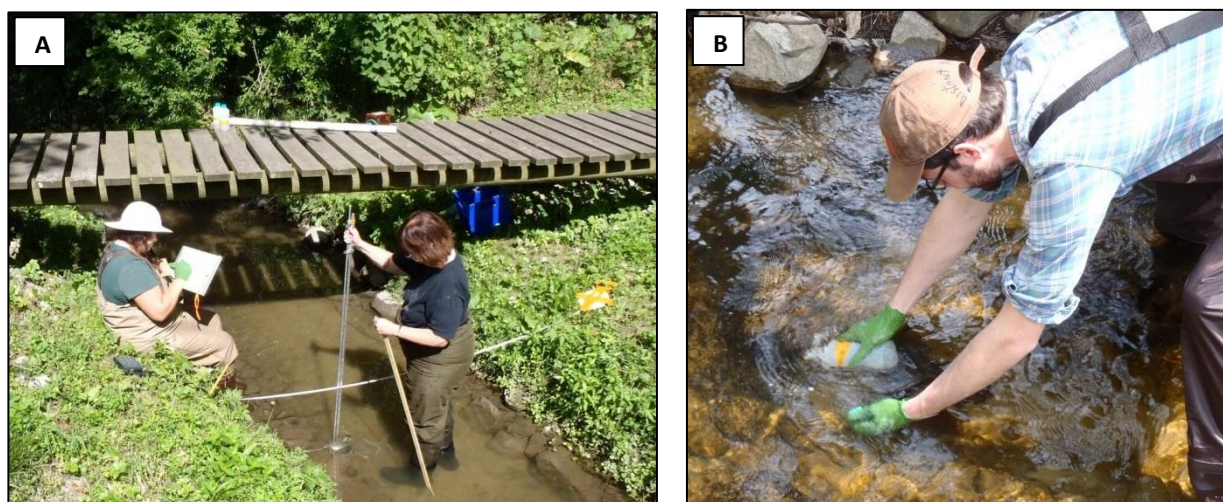
**Figure 2.1:** Researchers measuring streamflow (discharge) in Fremont Drain (A) and collecting water samples from Brooks Creek (B).

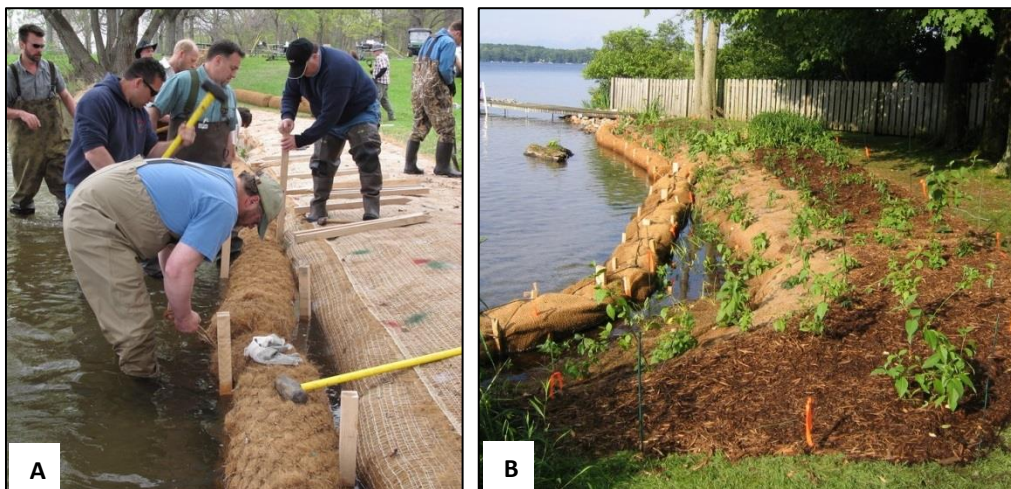
**Figure 5.4:** Installation of coir logs on Kent Lake, Oakland Co. (A), and a few weeks after installation of erosion blanket and brush bundle (B) on Gull Lake, Kalamazoo Co.
